The (4) Vessel Tops in the FLEX Digestion Oven contain O-rings (PN 9231) which provide a seal to the Digestion Vessels and should be replaced if leaking. When a leak occurs, first check that the O-ring is clean and that the mating surface (Vessel) is also clean and undamaged. If the leak persists, then replace the O-ring as follows:

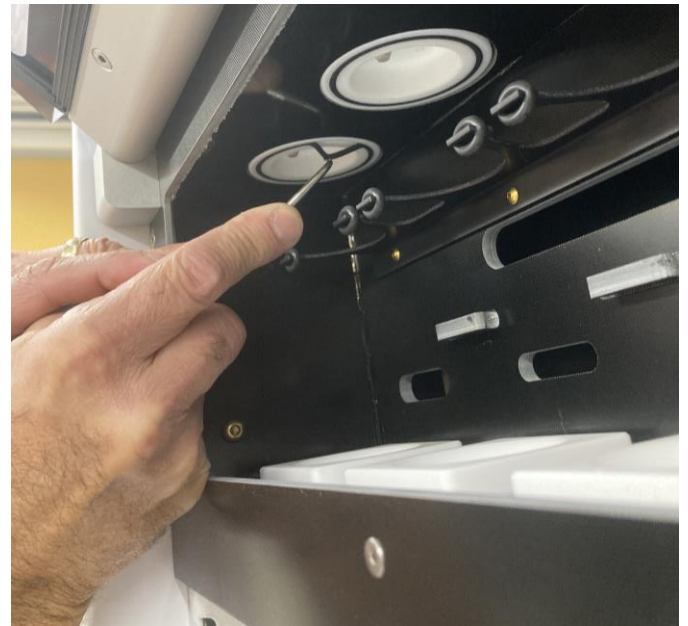
2. Gently push the point of the Pick into the rubber O-ring and lift it from the groove. Avoid damaging the groove with the Pick.

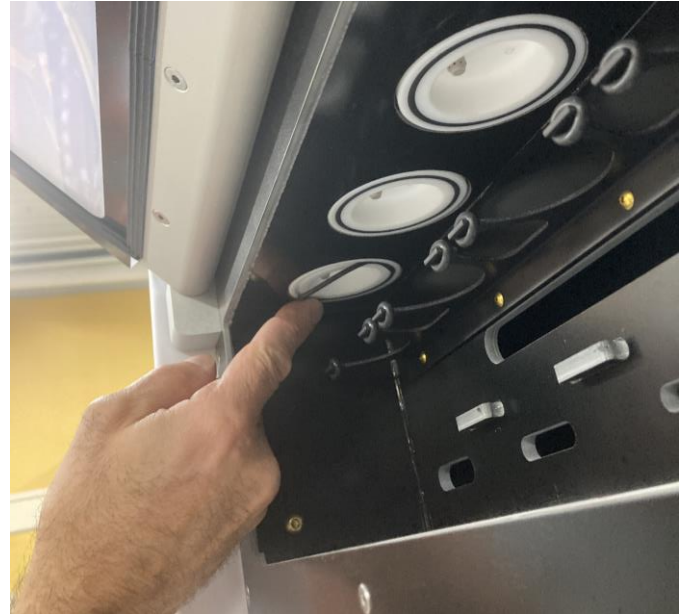
3. Clean any residue from the groove with water. Dry the groove and install the new O-ring. Ensure that it is pushed all the way into the groove.
