FLEX54 Vessel Bottom Assembly – O-Ring Replacement FLEX

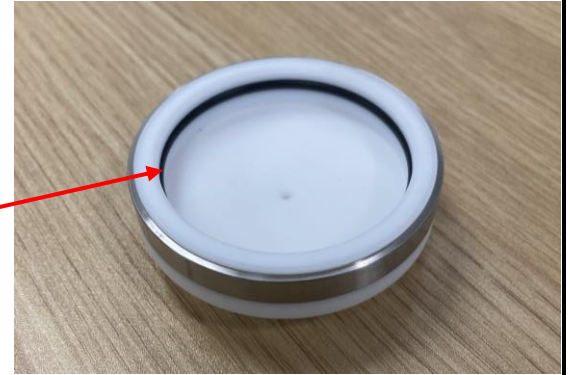
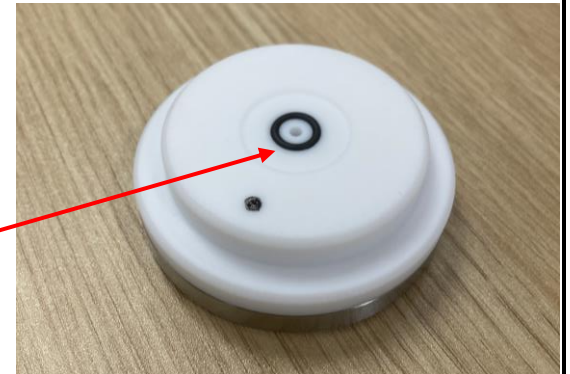
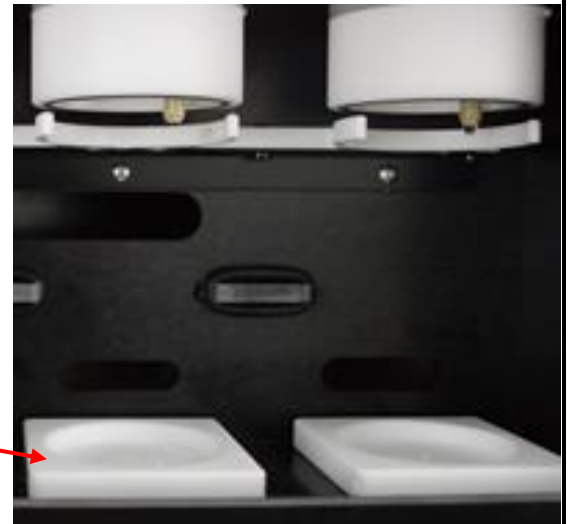
The FLEX54 Vessel Bottom Assembly contains two o-rings as shown below. PN 9423 provides a seal to the Digestion Oven and should only be replaced if a leak occurs. PN 9424 provides a seal to the Digestional Vessel and should be replaced if leaking or after (250) Runs.

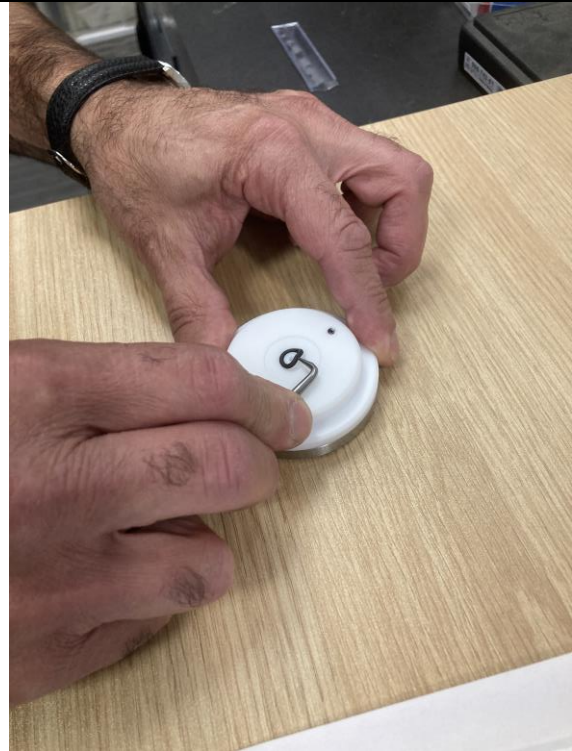
2. PN 9423 Replacement

Gentle push the point of the Pick into the rubber o-ring and lift it from the groove. Avoid damaging the groove with the Pick.

Select the 90 Degree Angled Pick PN 9488 from the provided Tool Kit.

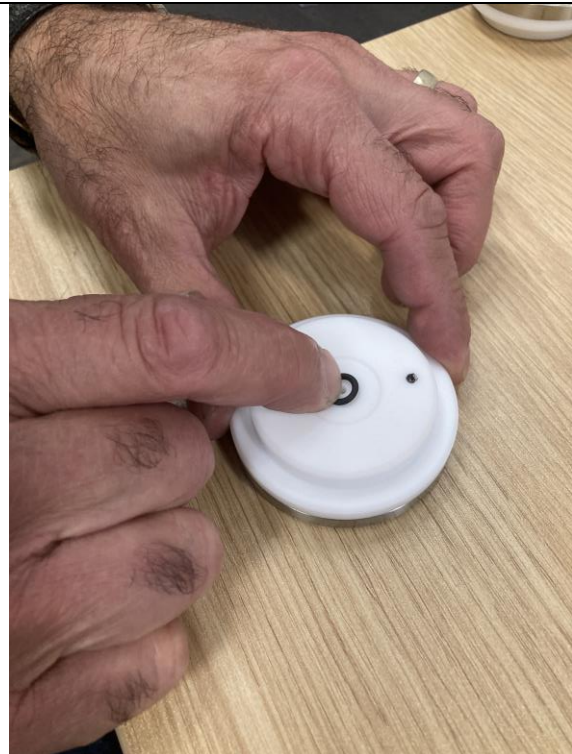
3. Clean any residue from the groove with water. Dry the groove and install the new o-ring. Ensure that it is pushed all the way into the groove.

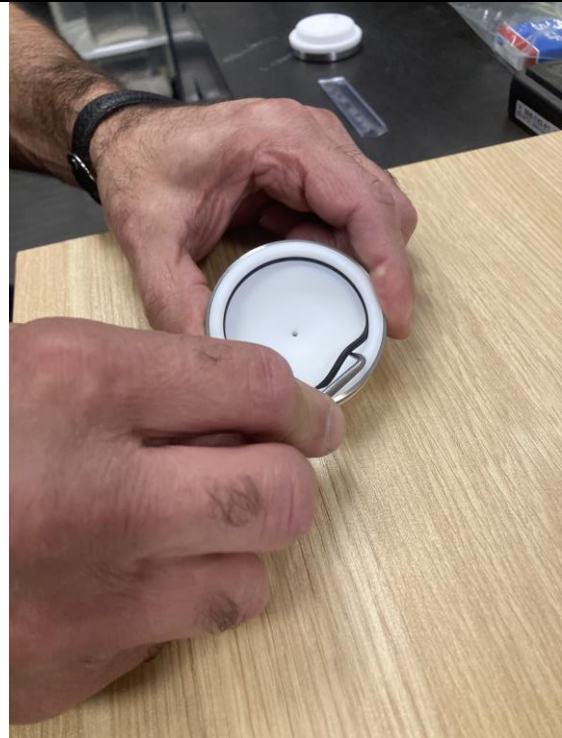
4. PN 9424 Replacement

Gently push the point of the Pick into the rubber o-ring and lift it from the groove. Avoid damaging the groove with the Pick.

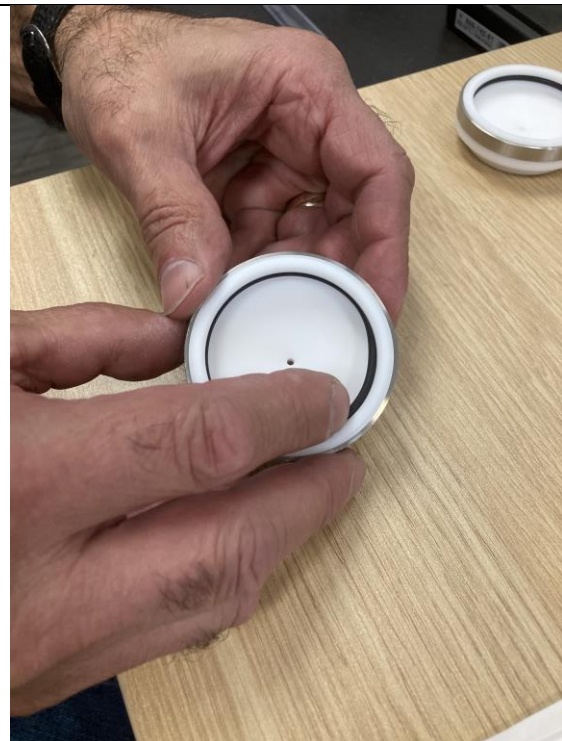
**5. Clean any residue from the groove with water. Dry the groove and install the new o-ring. Ensure that it is pushed all the way into the groove.**
