This procedure is for the ANKOM A200/A200I and can be used for the replacement of any or all of these parts and assemblies.

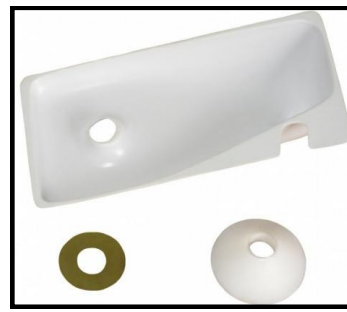
8. Remove the F27 Maintenance Alert Inner Assembly (drip tray, Teflon apron and brass washer) and set aside. If any of these parts are damaged or worn, replace F27.
9. From inside the vessel, twist and pull up to remove the agitator.

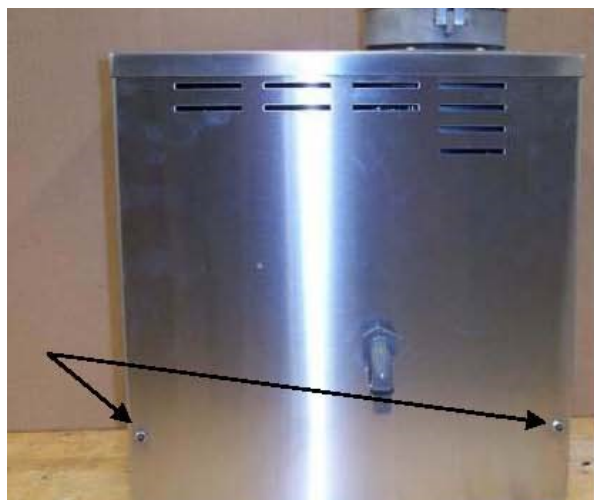
1. Turn off the power to the machine and unplug the A200/A200I instrument to be serviced.
2. Place cardboard on a table. Lay the A200/A200I on it's front. Remove the nuts that secure the back panel. Remove the panel. Remove the feet and mounting screws, then remove the bottom panel.
3. Inspect the Helical Coupler. If this is broken, order part # 632 for replacement.

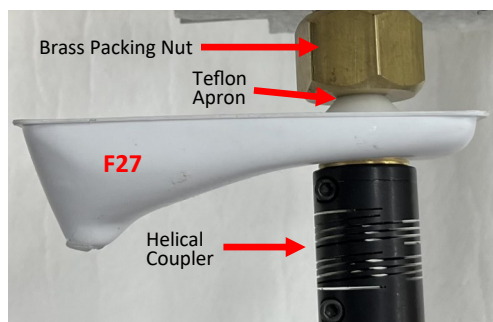
Step 4

4. Loosen the Brass Packing Nut until it is finger loose.
5. Loosen the upper set screw on the Helical Coupler.
6. Remove the nut and two bolts that secure the motor bracket in place.
7. Set the motor with bracket aside. Wires can be disconnected at the quick disconnect terminals if needed.

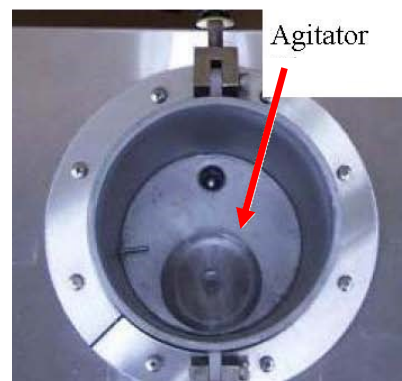
10. Check the agitator for wear and pitting in the shaft surface. The surface should be very smooth without grooves, pits or a thinned diameter.
11. The F28 Agitator with packing set can be installed if needed.
12. Follow subsequent steps and, if necessary, replace the agitator that comes with the F28 assembly.

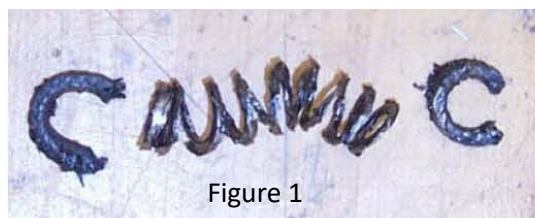
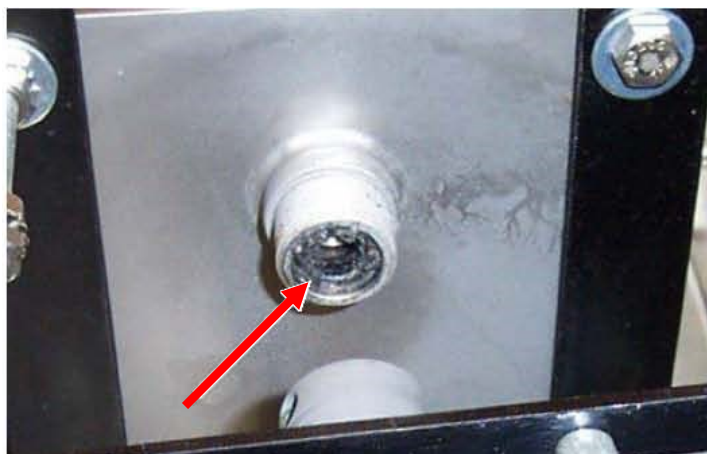
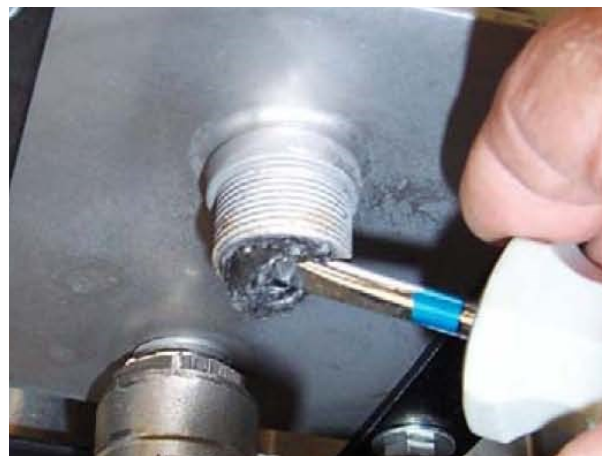
14. Using a screwdriver, remove the two carbon ropes and one compressed graphite cylinder. When removed, it will look similar to figure 1. **Ensure both ropes are removed or the new packing will not fit.**

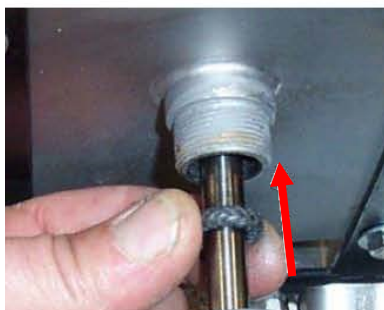
16. Using the 1st new carbon rope (from the F26 or F28 assembly) wrap this around the shaft and push into the nipple. Push the graphite cylinder into the nipple as far as it will go.
17. Install the PEEK Bushing and Brass Packing Nut (part #640) onto the agitator shaft. Temporarily use the packing nut, tightening and compressing the packing.

18. Remove the Brass Packing Nut and PEEK bushing. Now install the 2nd carbon rope. Reinstall the PEEK bushing and the Brass Packing Nut. Confirm that the agitator is resting against the bottom of the vessel before final tightening of the Brass Packing Nut. Tighten the Brass Packing Nut. The packing is compressed enough when the bushing top is flush with the nipple bottom after the 2nd rope is installed.

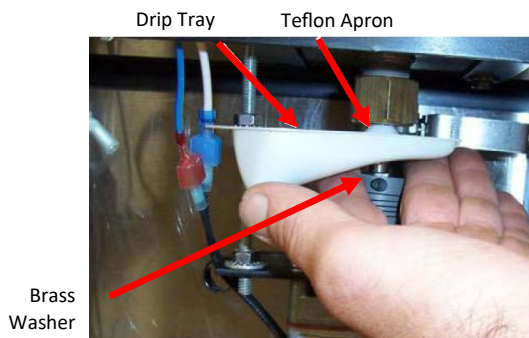
Step 19

19. Reinstall F27 Maintenance Alert Inner Assembly (Teflon apron, drip tray, and brass washer), either a new one or the original assembly removed earlier. Finger tighten the two nuts against the drip tray on the left threaded rod.
20. Reinstall the motor assembly and connect the wiring if this was disconnected. Loosely reattach the nut and two bolts (with washers) from the motor bracket.

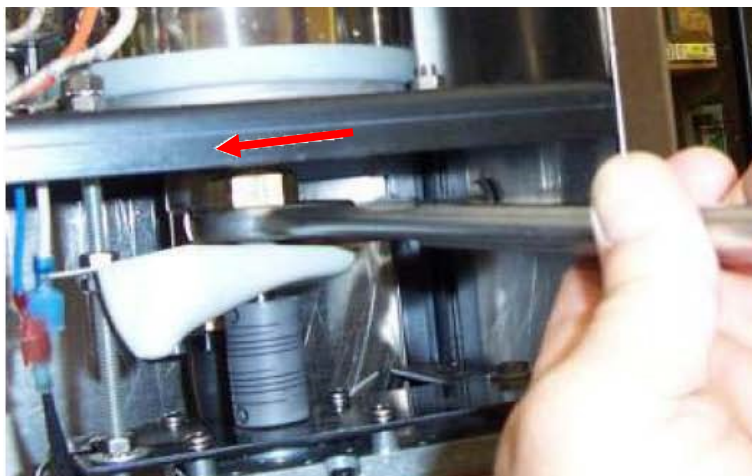
24. To tighten the Packing Nut, turn the motor on, using the AGITATE button. When the motor is activated, turn the Packing Nut to the right until you stall the motor.
25. Loosen the Packing Nut until the motor starts to run, then loosen the Packing Nut off slightly more, (approximately an additional 1/8 turn)
26. Turn the instrument off and replace the back cabinet.
