2. Remove the X62 Solvent Drain Valve Assembly.

3. Install the new X62 Solvent Drain Valve Assembly.

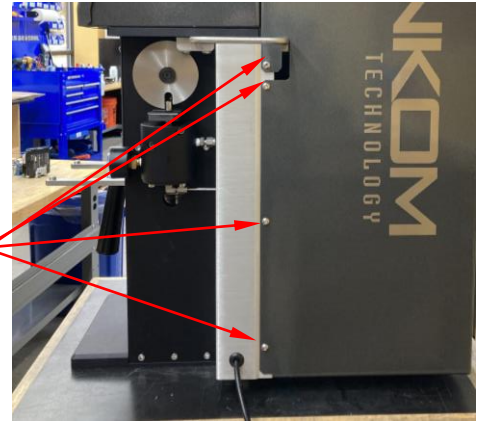
Figure 1

- a. Remove the eight screws (four on each side of the instrument) that secure the back cabinet onto the instrument using a 1/8" Allen wrench. Set aside the screws for later use.
- b. Lift up then pull back so the handles on each side slide out of the notched groove.

Screws

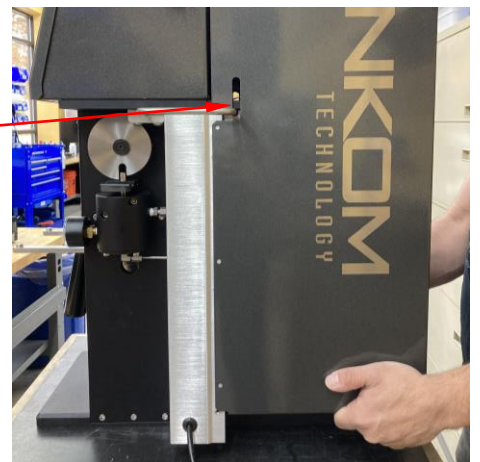
Figure 2

Notched groove

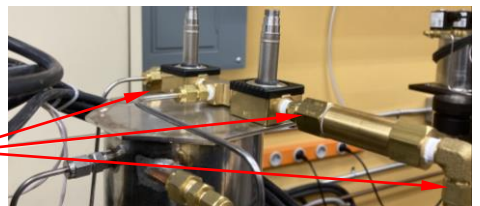
Figure 4

- a. Remove the two electrical plugs (Q5 & Q6) using a 9/16" wrench.
- b. Loosen the three brass nuts with a 7/16" wrench.
- c. Remove the two screws on the bottom of the condenser's top plate using a Phillips head screwdriver. Set aside the screws for later use. See Figure 5.
- d. Remove the old X62 Solvent Drain Valve Assembly.

Brass Nuts

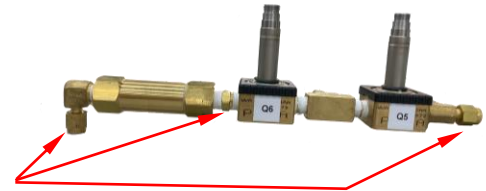
Figure 6

- a. Remove the brass nuts from the new X62 Solvent Drain Valve Assembly and discard.
- b. Secure the new X62 on top of the condenser using the two screws set aside in step 2c.
- c. Finger tighten the brass nuts onto the new X62. Then tighten no more than 1/8" turn with a 7/16" wrench.
- d. Place each electrical plug onto the valve stem with its corresponding number. For example, Q5 electrical plug should be placed onto the Q5 valve coil.

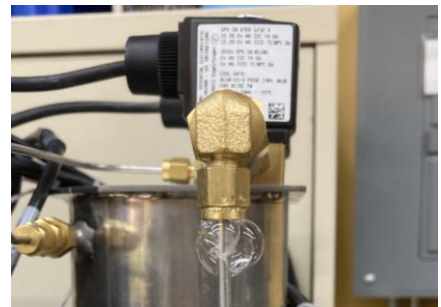
- a. Perform a run with the back cabinet off.
- b. Put soapy water on all the fittings that were removed while replacing the XT Solvent Valve Assembly.
- c. Look for bubbles. If there are bubbles that means there is a leak and the fitting needs to be tightened.
- d. Use a wrench to tighten the nut until the bubbling stops.
- e. Wipe off the fitting and check again for leaks.
