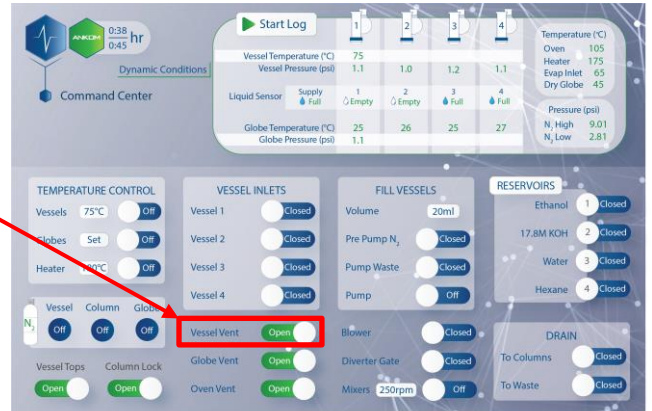
1. From the HMI Command Center, make sure the Vent Valve is in the Open position.

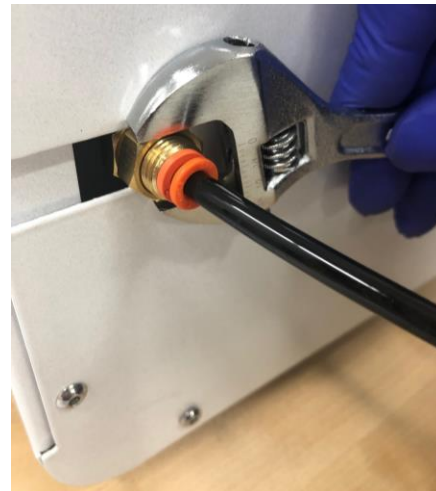
4. Use an adjustable wrench to slightly loosen the hex nut on the rear panel nitrogen fitting while keeping the nitrogen connected.

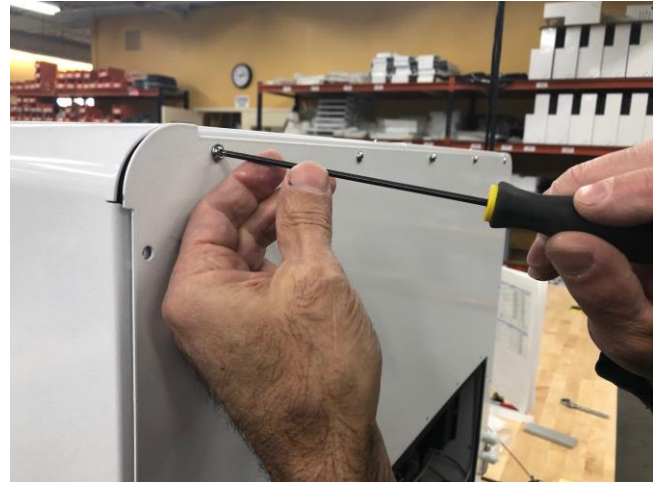
5. Using the same 1/8" Hex Driver, remove the (20) Rear Panel screws from the back of the Instrument.

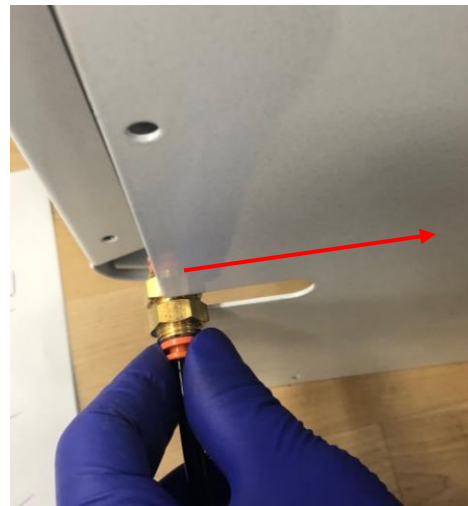
6. Slide the Nitrogen fitting out of the slot in the Rear Panel and remove the panel from the Instrument.

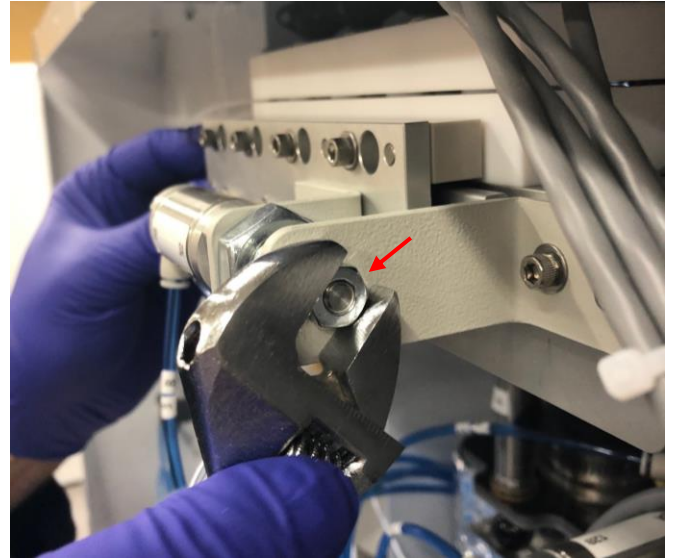
10. Use an adjustable wrench to remove the hex nut on the end of the air cylinder.

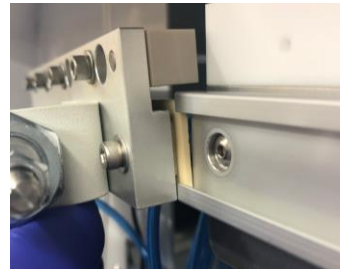
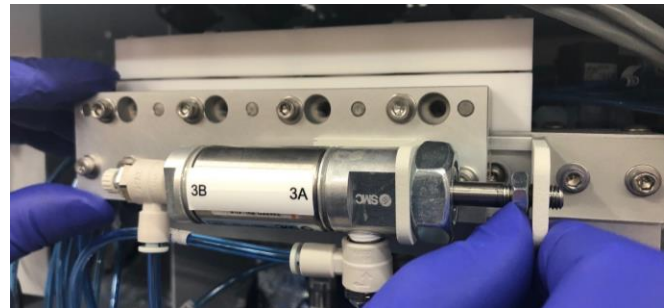
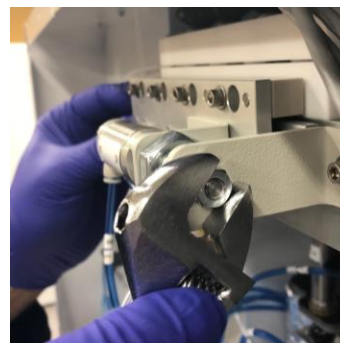
14. Slide the Connector back into the carriage rail. Move it to the right to engage the air cylinder rod back into the bracket. Reinstall and tighten the nut on the end of the air cylinder.

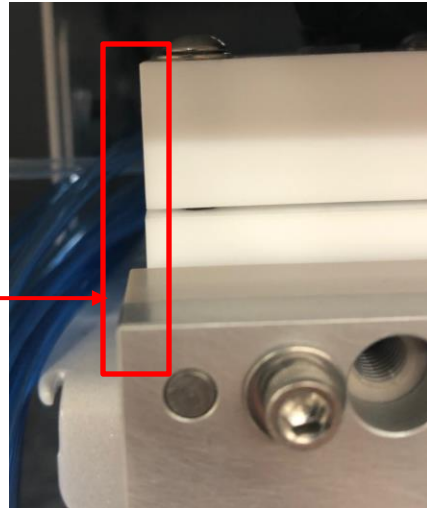
15. Verify that the end of the Slide Bar is even with the edge of the white manifold. If it is not, the two nuts on the end of the air cylinder must be adjusted to align the Slide Bar.

Adjustment Required

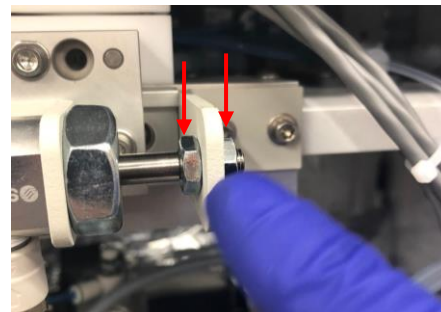
16. Verify that the two nuts on the air cylinder are both tight against the bracket.
