**NOTE:** Before this procedure, make sure the stainless steel (older versions have copper) surface in vessel bottom is clean. Dirt buildup can cause ETS fault.

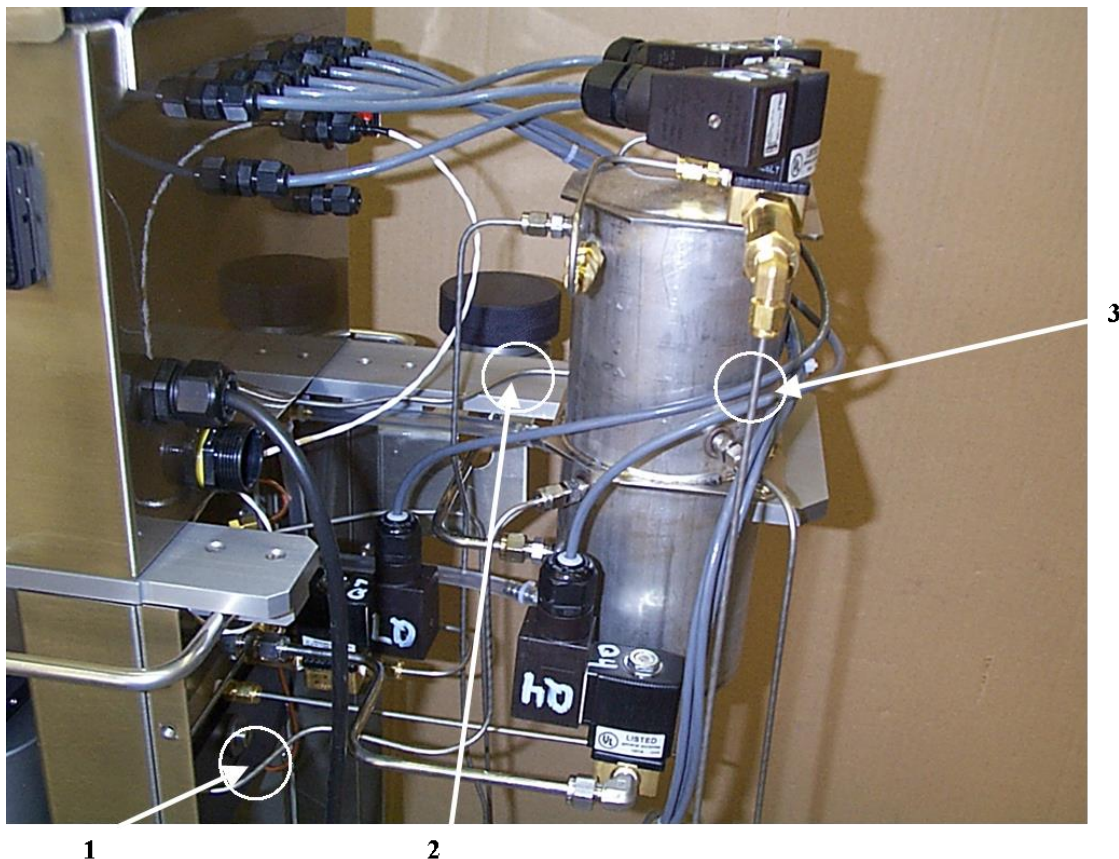
**3. Check tubes 1, 2, and 3.**

**4. If tube 1 is hot, this means the safety valve needs to be replaced. (ANKOM part #X72)**

**5. If tube 2 is hot, this means valve Q5 is leaking and needs cleaning.**

**6. If tube 3 is hot, this means valve Q6 is leaking and needs cleaning.**

**7. If none of the tubes are hot to the touch, then check all fittings and vessel o-rings for leaks.**
